## PROPERTY INSPECTION REPORT

**Concerning:** XXX

**By:** Arturo Marquez TREC PI#2685 01/24/2014 (Name and License Number of Inspector) (Date)

**2, 1-story duplex residence buildings**

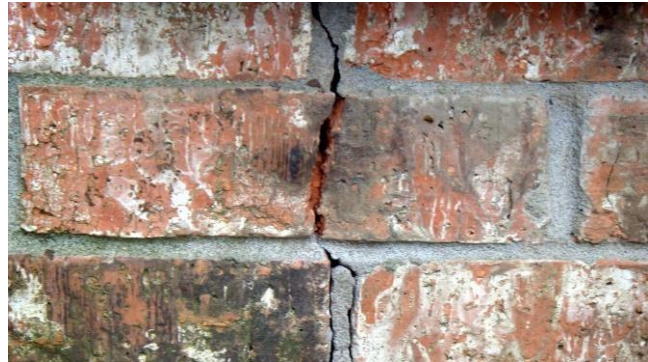
B

*Comments:* Cracks were observed on the left, rear, and right sides of both buildings, [see sample pictures-A,B,C,D,I,J.&K](#), on the rear grade beam, [see sample picture-L](#), and on home's interior walls, [see sample pictures-E,F,G,H.&M](#). Differential movement in excess of marginal was detected using a four ft. digital level on both building slabs; marginal being described as up to ¼ inch deflection in a four ft. span and/or up to 1 inch deflection in a fifteen ft. span.

**It is this inspector's opinion these foundations need to be raised and/or stabilized.** This may be accomplished with the use of piers. Need to contact a qualified foundation repair contractor and/or engineer for specifications and cost. It is also recommended that a monitoring and maintenance program be initiated in an effort to minimize possible future differential movement.

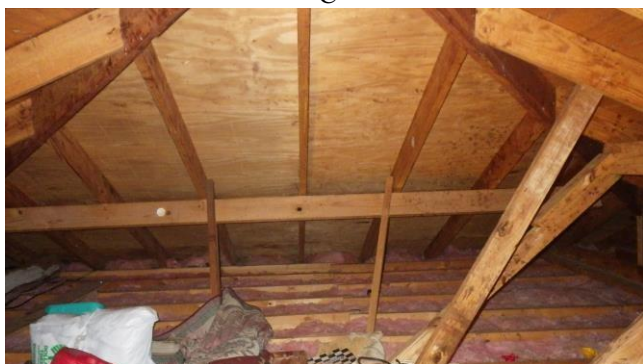
D

**However,** need to install additional insulation in all attics to provide a minimum R-19, preferably an R-30 rating. Need to provide missing attic firewall protection between units, see sample pictures-D&I. Moisture stains and/or moisture damage from roof leaks were also observed in attics, see sample pictures-E,K,&L; need to contact a qualified roofer. All attic drop ladders were either damaged, missing steps, and/or not resting flush when fully extended; this creates potential safety hazards. Evidence of rodent activity (droppings) was also observed in attics, see sample pictures-F&J; need to also contact a qualified pest operator.

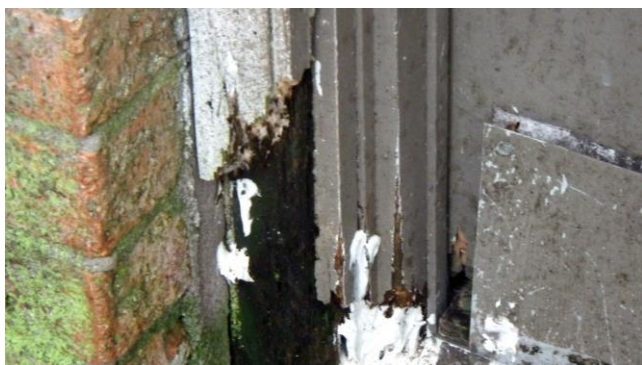
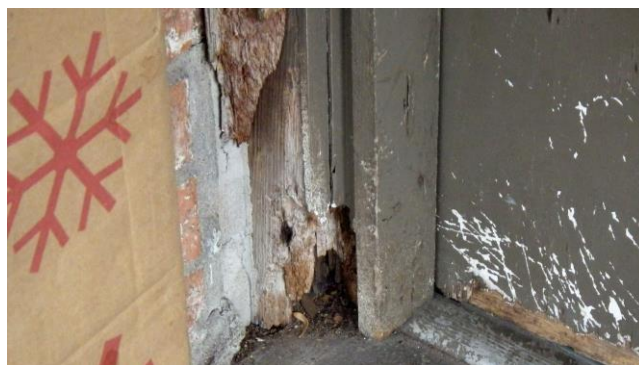
☒ ☐ ☐ ☒ **G. Doors (Interior & Exterior)** *Comments:* Moisture damage was observed on the rear exit door jambs and doors, see sample pictures-A&B. Need to caulk all the door frame/brick veneer junctions, see sample picture-C.

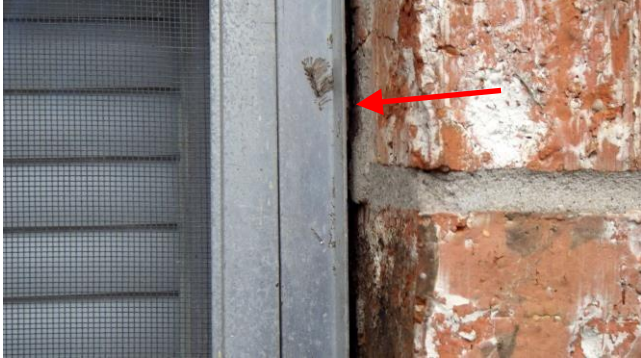
**H. Windows** *Comments:* Single paned aluminum framed windows are present. Not all windows readily accessible due to furniture. **However**, need to caulk all window/brick veneer junctions, see sample picture. Several missing screens were observed.

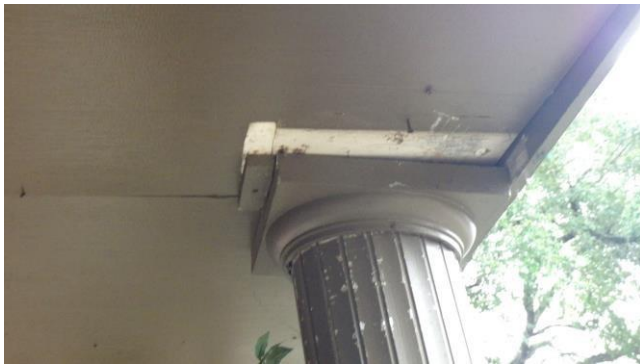
**K. Porches, Balconies, Decks, and Carports** *Comments:* All porch columns are out of plumb/leaning, see sample picture.

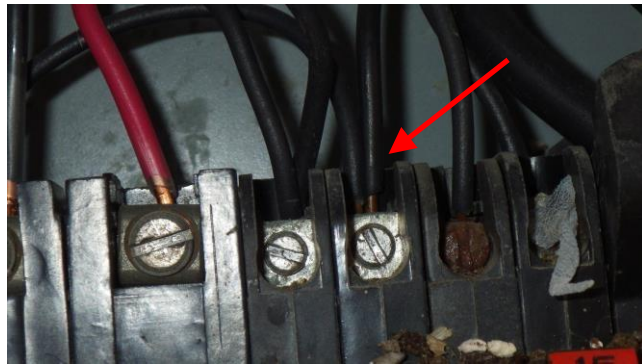
C

**A. Service Entrance and Panels** *Comments:* Load calculations were not performed. These are Federal Pacific panel boxes, see sample pictures-A,B,D,&E. Unit 9125 and 9121 each have a 100amp main breaker. Systems were observed operable. **However**, need to properly label all breakers. And, unit 9125 has a few single-pole breakers with multiple circuit wires connected, see sample picture-C, instead of the required single-wire connection.

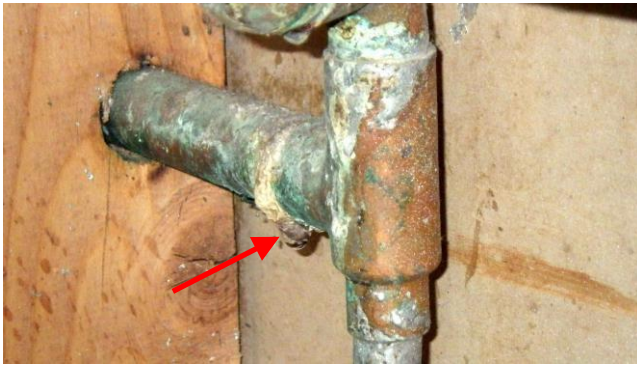
*Comments:* A leak was observed in 9127 on tub hot water faucet handle. The bathroom sink lacks a drain plug in 9127, in 9123, and in 9121. A leak was observed on water line next to water heater in 9125, see sample picture-A. Simultaneous water flow was observed at 9125 bathtub spout and shower head when shower head is in use; this indicates a probable faulty/worn shower diverter valve seal. A patch/repair and missing drain plug lever on bathtub was observed in 9123, see sample picture-B. Simultaneous water flow was also observed at 9123 bathtub spout and shower head when shower head is in use. Need to replace cracked toilet tank lid in 9121. Continuous leaks/drips were observed at kitchen sink faucet and at bathtub faucet in 9121. A leak was also observed at bathtub shower diverter valve handle in 9121.

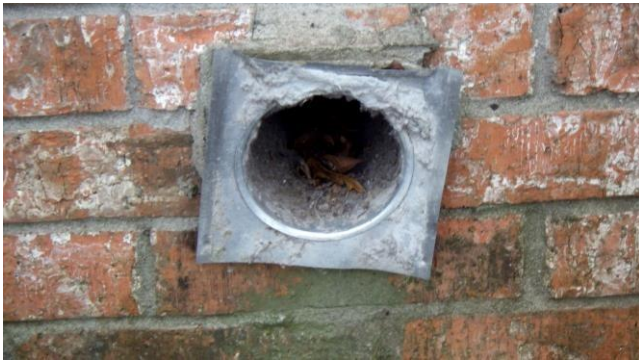
**H. Dryer Exhaust Systems** *Comments:* Need to properly install missing grill covers at all exterior vents, see sample picture.
