## PROPERTY INSPECTION REPORT

**Concerning:** XXX

**By:** Arturo Marquez TREC PI#2685 01/24/2014 (Name and License Number of Inspector) (Date)

**2, 1-story duplex residence buildings**

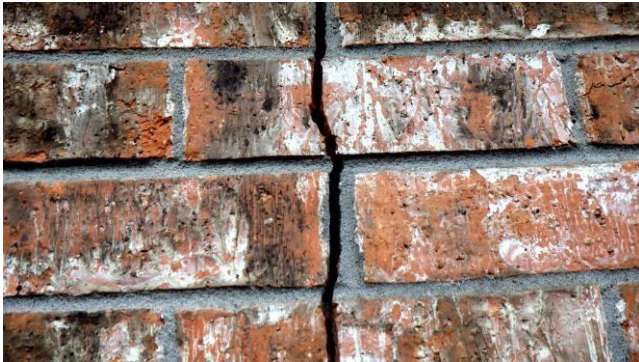
A

*Comments:* Cracks were observed on the left, rear, and right sides of both buildings, [see sample pictures-A,B,C,D,I,J.&K](#), on the rear grade beam, [see sample picture-L](#), and on home's interior walls, [see sample pictures-E,F,G,H.&M](#). Differential movement in excess of marginal was detected using a four ft. digital level on both building slabs; marginal being described as up to ¼ inch deflection in a four ft. span and/or up to 1 inch deflection in a fifteen ft. span.

**It is this inspector's opinion these foundations need to be raised and/or stabilized.** This may be accomplished with the use of piers. Need to contact a qualified foundation repair contractor and/or engineer for specifications and cost. It is also recommended that a monitoring and maintenance program be initiated in an effort to minimize possible future differential movement.

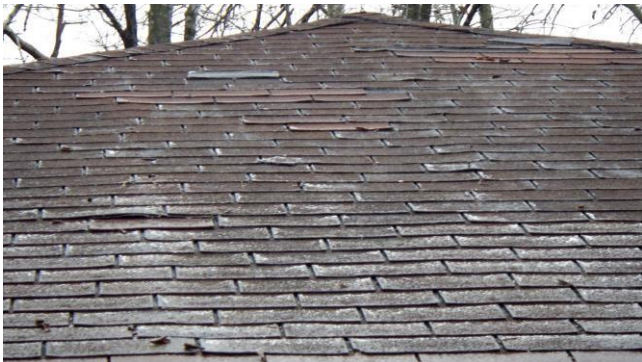
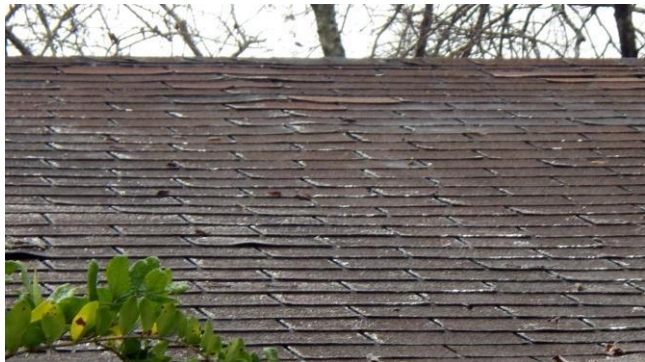
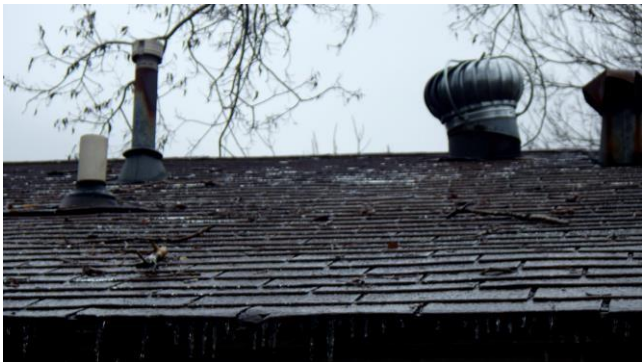
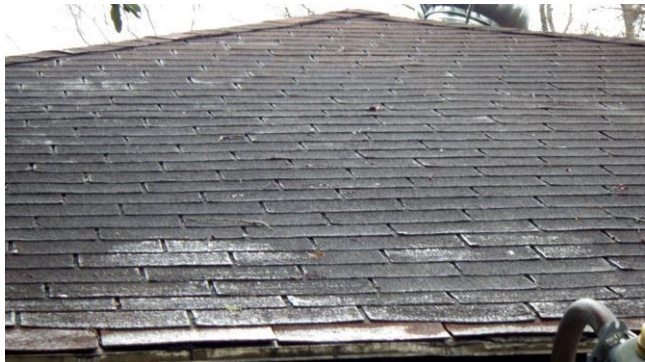
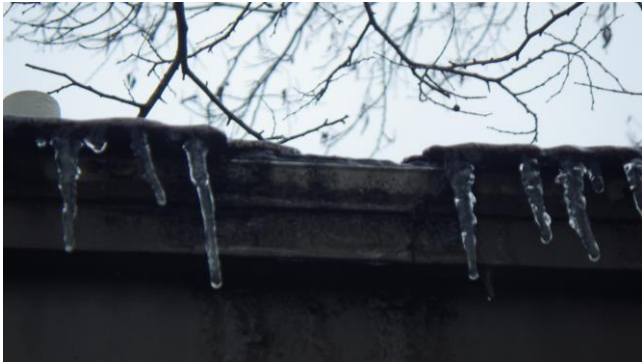
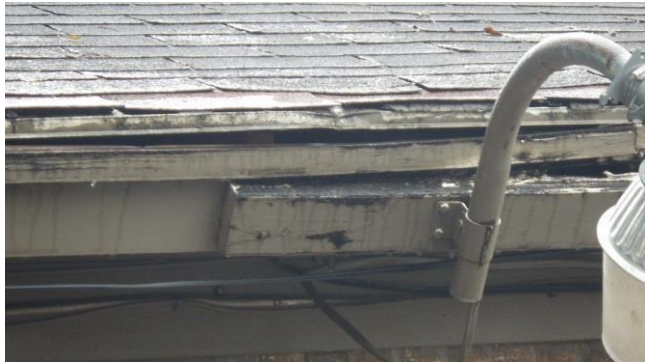
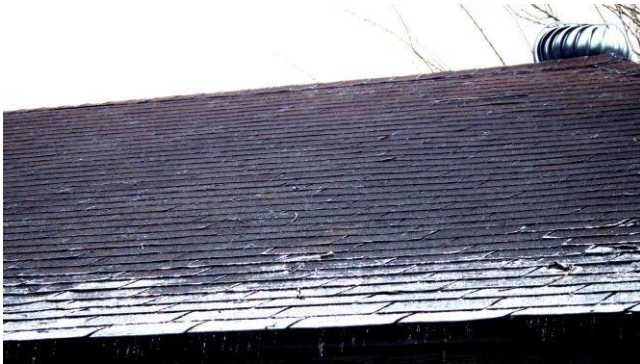
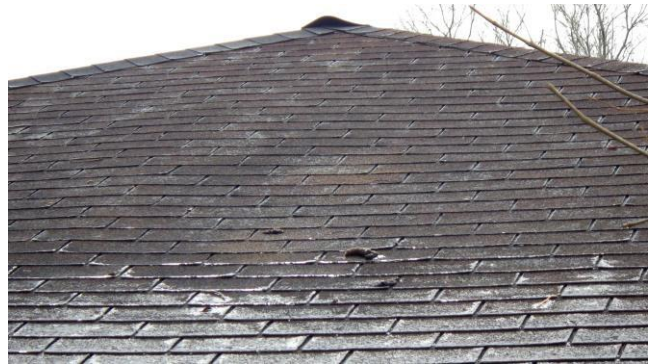
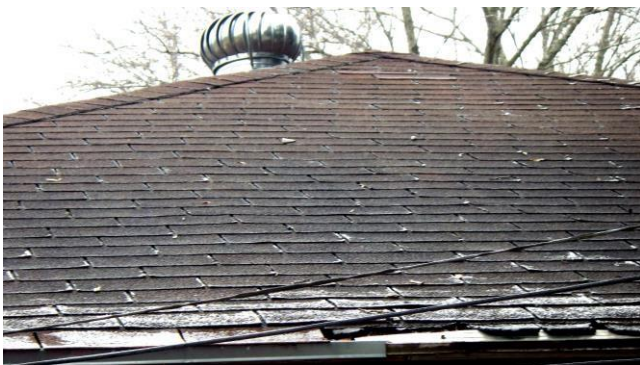
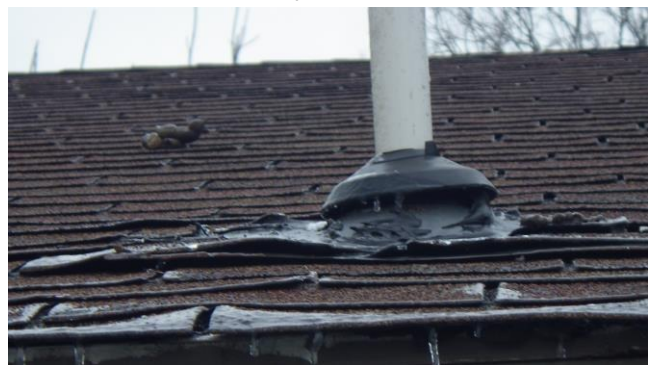
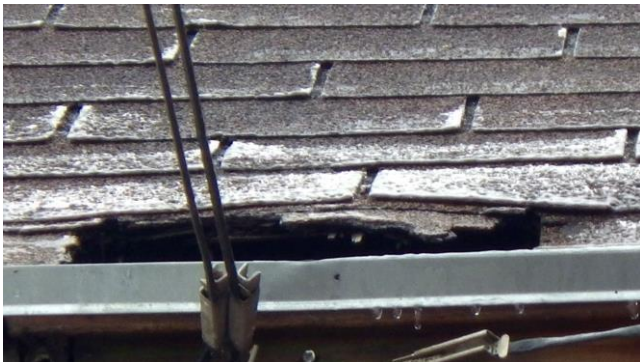
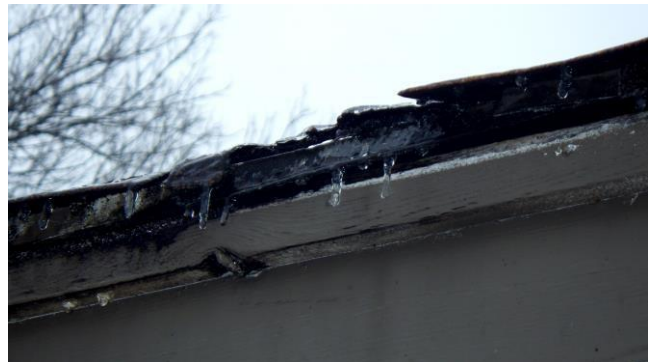
*Comments:* Several damaged shingles were observed. It is this inspector's opinion that the amount of curling and granular loss indicate these roof coverings to be in their last stage of expected useful lifespans, see sample pictures-A,B,C,D,E,F,G,H,I,J,K,&L. **Need to contact a qualified roofer for repair/replacement specifications and cost.**

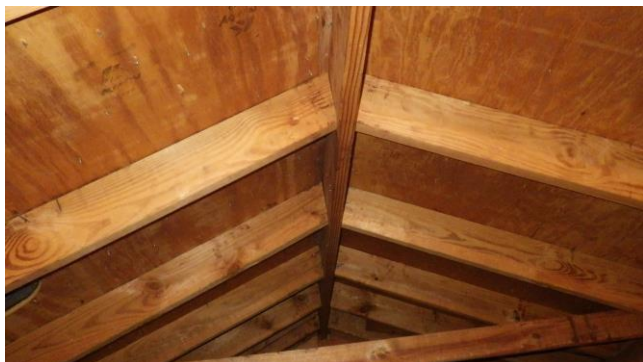
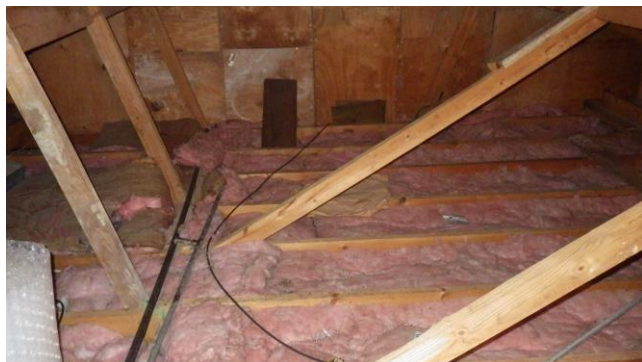
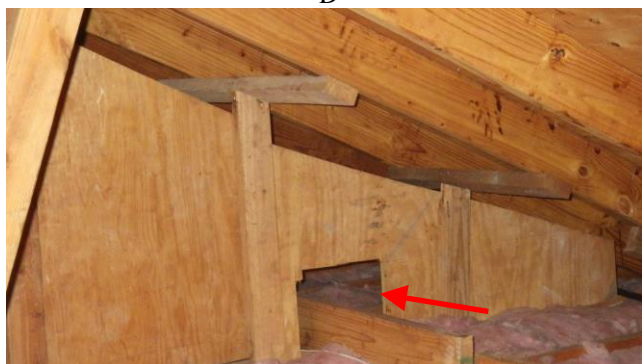
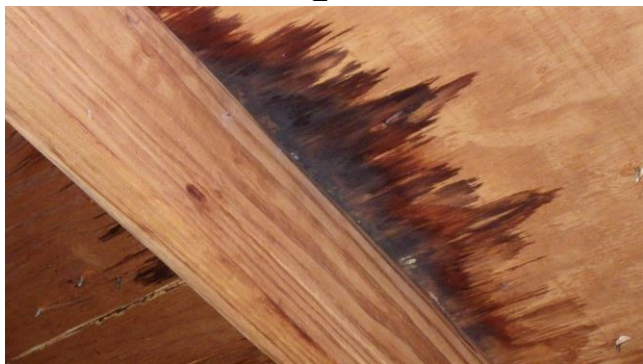
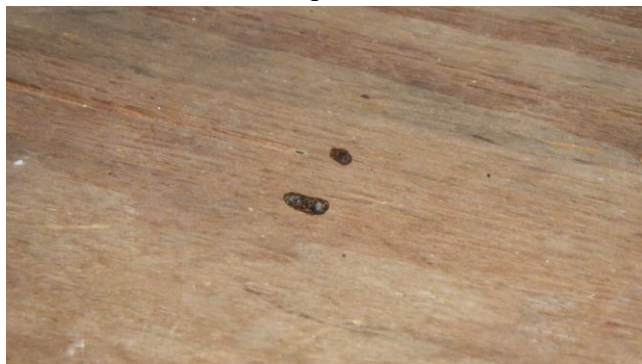
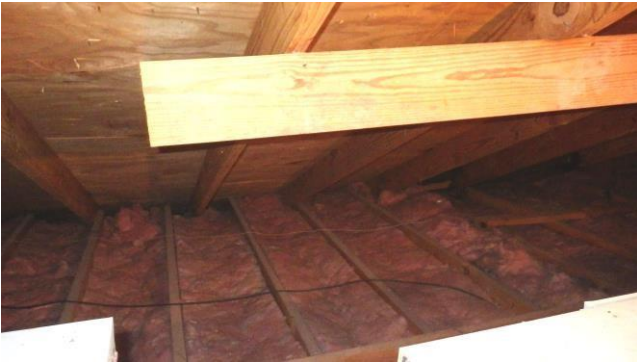
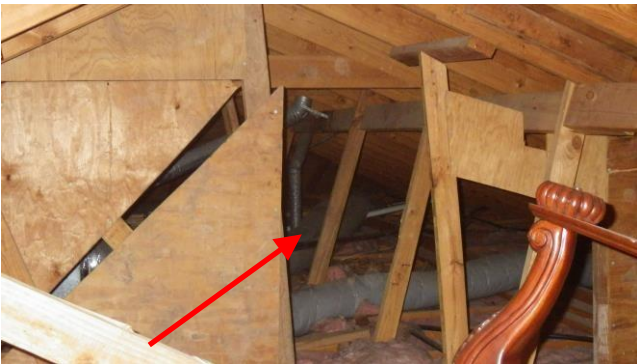
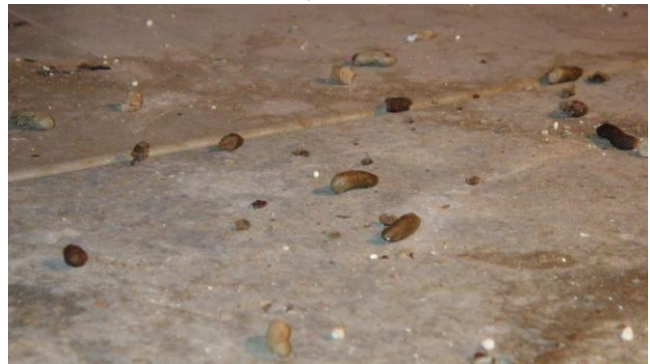
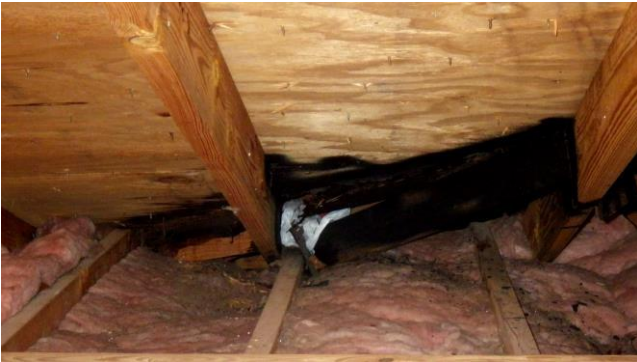
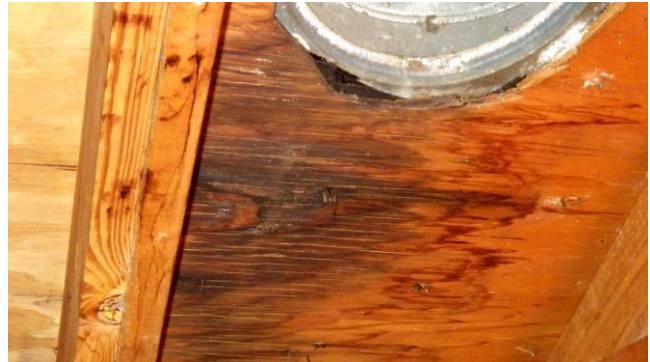
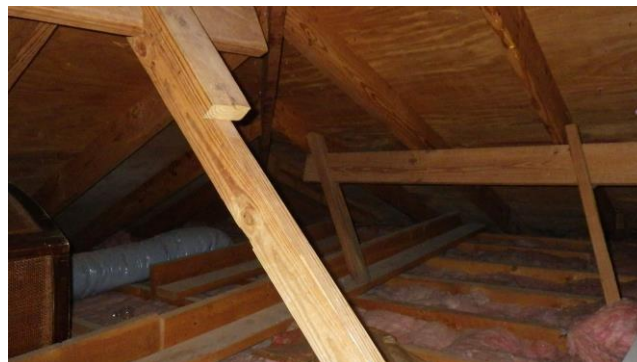
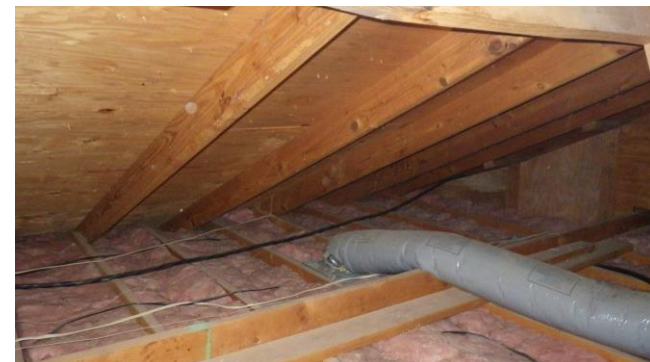
*Comments:* Visible components were observed operable, see attic sample pictures-A,B,G,H,M,&N.

**However,** need to install additional insulation in all attics to provide a minimum R-19, preferably an R-30 rating. Need to provide missing attic firewall protection between units, see sample pictures-D&I. Moisture stains and/or moisture damage from roof leaks were also observed in attics, see sample pictures-E,K,&L; need to contact a qualified roofer. All attic drop ladders were either damaged, missing steps, and/or not resting flush when fully extended; this creates potential safety hazards. Evidence of rodent activity (droppings) was also observed in attics, see sample pictures-F&J; need to also contact a qualified pest operator.

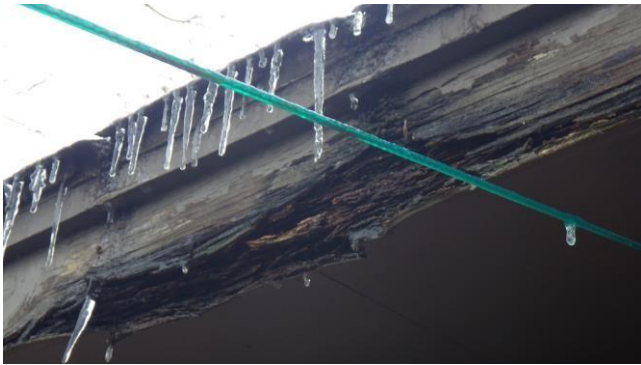
A

- ☒ ☐ ☐ ☒ **E. Walls (Interior & Exterior)** *Comments:* Moisture damage was observed on several fascia boards, drip edge boards, soffit panel, and porch ceilings, see sample pictures-A,B,C,D,E,F,&G; some of this damage is due to roof leaks. This wood rot also creates conducive conditions for possible wood destroying insect infestation. Evidence of wood destroying insect damage was observed on dining area wall in 9121, see sample picture-H, need to also refer to wood destroying insect report. Building 9125&9127

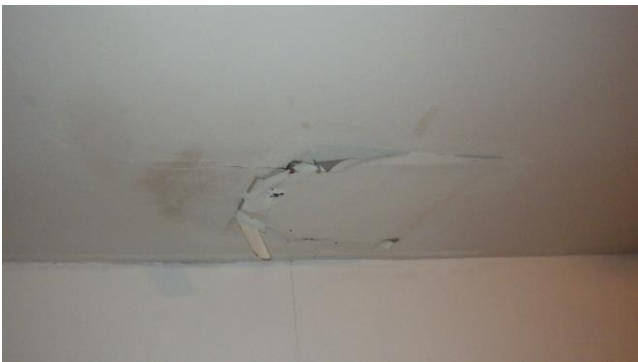
☒ ☐ ☐ ☒ **F. Ceilings & Floors** *Comments:* A large ceiling patch/repair was observed in living room for 9121. Moisture stains/damage was observed on ceilings in 9125 front right bedroom, and in 9123 bedroom closet, see sample pictures-A,B.&C, possibly from roof leaks. Wood destroying insect damage was observed at 9121 kitchen ceiling/wall junction, see sample picture-D; need to also refer to wood destroying insect report.

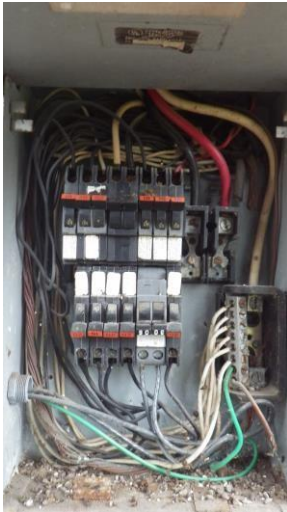
A

**A. Service Entrance and Panels** *Comments:* Load calculations were not performed. These are Federal Pacific panel boxes, see sample pictures-A,B,D,&E. Unit 9125 and 9121 each have a 100amp main breaker. Systems were observed operable. **However**, need to properly label all breakers. And, unit 9125 has a few single-pole breakers with multiple circuit wires connected, see sample picture-C, instead of the required single-wire connection.

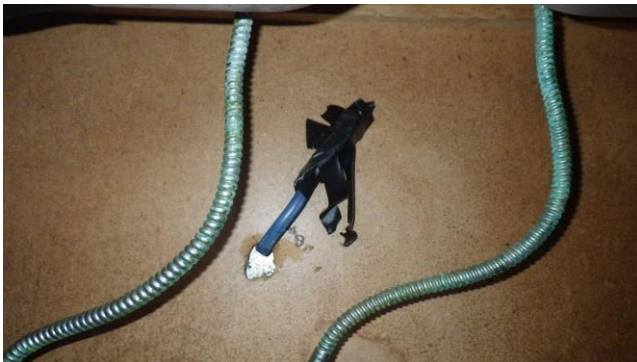
*Comments:* No doorbells present. Most receptacles are not readily accessible due to furniture and/or connected electronic devices. Accessible system and fixtures were observed operable. **However**, no GFCI protection present in any of the kitchens, bathrooms, or at exterior receptacles. No receptacle located in bathroom at 9127 or in 9123. Need to properly install missing smoke detectors inside each bedroom and outside bedrooms but in close proximity to sleeping areas. Need to properly protect/enclose electrical connection within in a junction box; this is located underneath the kitchen sink in 9125, see sample picture-A. These items present potential safety hazards. A broken exterior rear fixture was observed at 9121, see sample picture-B. No voltage detected on receptacle located on kitchen/living room wall in 9127. Need to contact a qualified electrician for needed repairs.

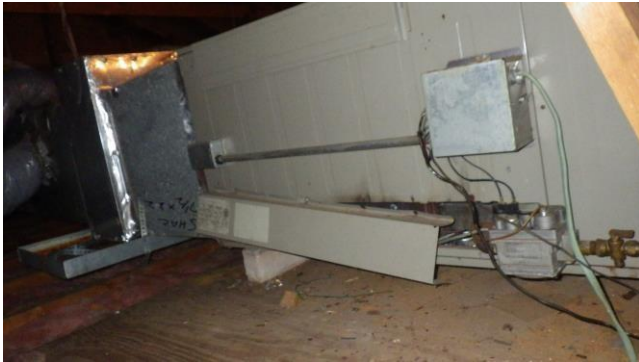
C

*Comments:* All units were turned on and observed functional, see sample pictures-A,C,&E. **However**, all units lack sediment traps at gas line connections, see sample picture-B. Need to replace the copper branch lines, see sample picture-D, with proper gas flexible lines in 9123 & 9125. Units in 9127, 9125, & 9123 appear to be 1984 models. Corrosion was observed in burner areas of these older models; no inspection was performed to check for possible heat exchanger cracks as this would involve dismantling of unit. It is this inspector's opinion these three older models have lived their expected useful lifespans. The gas flexible line in 9121 passes through an unprotected metal panel opening, see sample picture-F. **All units need to be properly serviced by a qualified technician.**

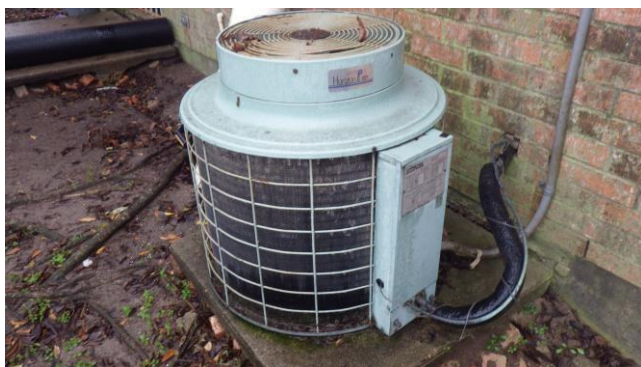
A

*Comments:* The condenser and coil housing units were observed in fair physical condition, see sample pictures-A,B,C,D,F,G,H,&I. Units all appear to be 2-ton models. The 9127 condenser appears to be a 1984 or 1988 model and coil a 1987 model. The 9125 condenser appears to be a 1998 model and coil a 2002 model. Exterior temperature was below 60F., preventing a proper operational status inspection of units. All units need to be properly evaluated when warmer temperature permits. **However**, corrosion was observed in secondary drain pan for 9125; this indicates a possible obstruction in primary or secondary condensate drain lines and possible coil corrosion damage. The 9123 condenser appears to be a 1992 model and coil a 2000 or 2005 model. The 9121 condenser appears to be a 1987 model and coil a 2000 model. Need additional insulation on coolant line in attic for 9125, see sample picture-E. **Units need to be properly evaluated by a qualified technician when warmer temperature permits.**

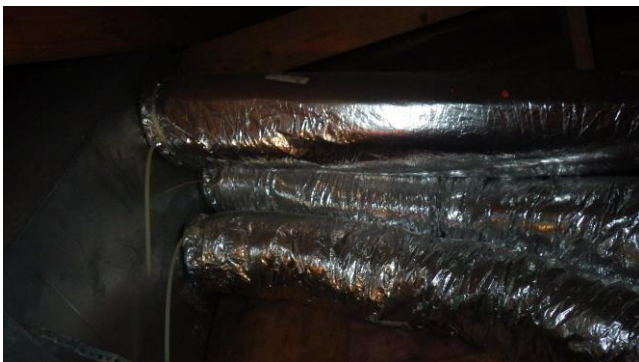
A

- C. Duct Systems, Chases, and Vents** *Comments:* Visible components were observed operable; no inspection was performed on duct interiors, see attic sample pictures-A,B,F,G,H,&I. **However**, torn insulation was observed on ducts in 9125, see sample pictures-D&E. Deteriorated seal/air-loss was observed at blower/duct housing seam in 9127, see sample picture-C. Systems need to be properly serviced by a qualified technician.

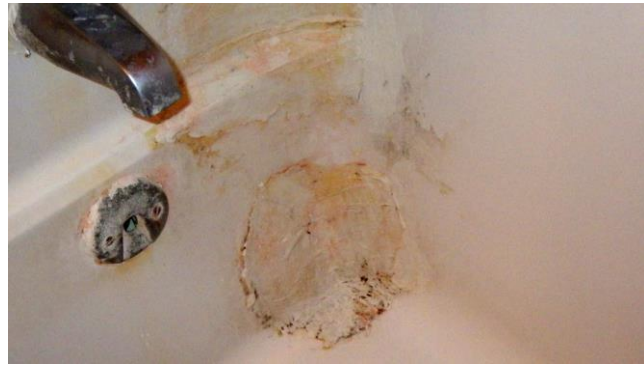
B

*Comments:* A leak was observed in 9127 on tub hot water faucet handle. The bathroom sink lacks a drain plug in 9127, in 9123, and in 9121. A leak was observed on water line next to water heater in 9125, see sample picture-A. Simultaneous water flow was observed at 9125 bathtub spout and shower head when shower head is in use; this indicates a probable faulty/worn shower diverter valve seal. A patch/repair and missing drain plug lever on bathtub was observed in 9123, see sample picture-B. Simultaneous water flow was also observed at 9123 bathtub spout and shower head when shower head is in use. Need to replace cracked toilet tank lid in 9121. Continuous leaks/drips were observed at kitchen sink faucet and at bathtub faucet in 9121. A leak was also observed at bathtub shower diverter valve handle in 9121.

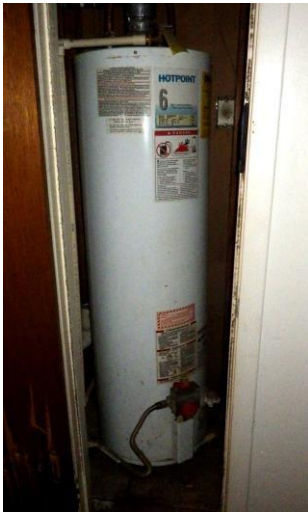
A

*Comments:* All units are interior installations. Unit in 9127 appears to be a 2000 model. Unit in 9125 appears to be a 1994 model. The I.D. plate for unit in 9123 is missing, preventing a proper determination of age. Unit in 9121 appears to be a 1998 model. All units were observed operable, see sample pictures-A,B,D.&E. **However**, each unit lacks a properly piped drain pan underneath tank. The T&P relief valve in 9125 is not properly piped to drain into a drain system or into a drain pan. Corrosion damage/evidence of a leak was observed on water line connection over the tank in 9125, see sample picture-C. All units lack a sediment trap at gas line connection. And, all units lack proper supply of combustion air, see sample illustration-F. **All units need to be properly serviced by a qualified plumber.**

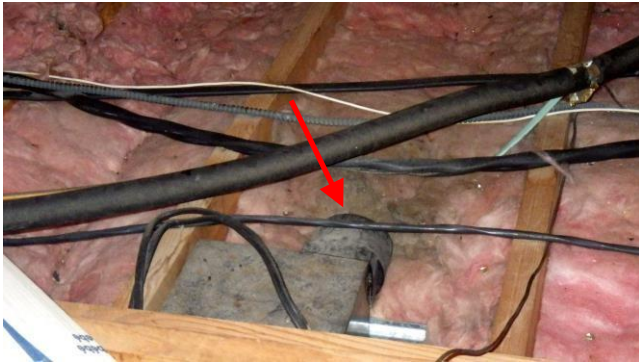
☒ ☐ ☐ ☒ F. Mechanical Exhaust Vents and Bathroom Heaters *Comments:* All units were turned on and observed operable. However, units need to be properly vented to the exterior instead of venting into the attic, see sample picture.
